Site Walk Report: Insulation (SV2)

File Number #8682 Building Code MN Code
Site Walk Date 2011-02-11

Home
29070 Dinsmore Ave
Randolph, MN 55065

Builder
Lakeland Custom
Remodeling
9390 212th St West
Lakeville, MN 55044

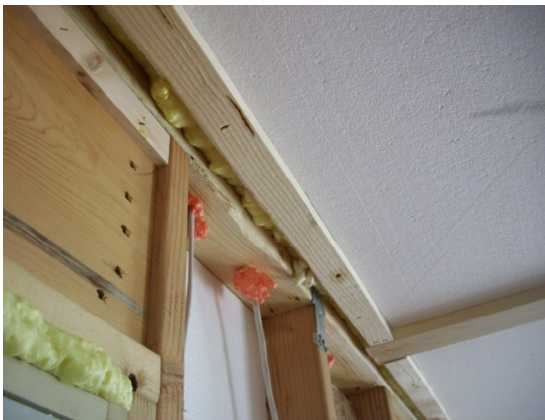
Figure 1.1

Top plate penetrations

Penetrations in framing can lead to uneven interior surface temperatures and unconditioned air leakage into the structure. Seal penetrations before insulation and vapor retarder are installed.

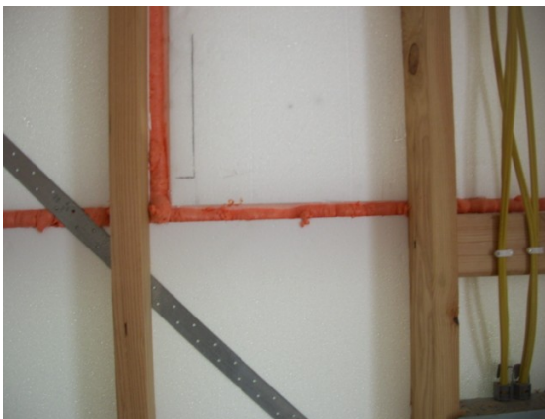
Figure 2.1

Insulation missing/voids/compressions

Insulation performance is reduced by voids and leads to building durability issues, uneven interior surface temperatures, occupant discomfort, and high utility costs. Install insulation in all cavities for full thermal coverage, without voids, gaps, and compressions and in full contact with the vapor barrier.

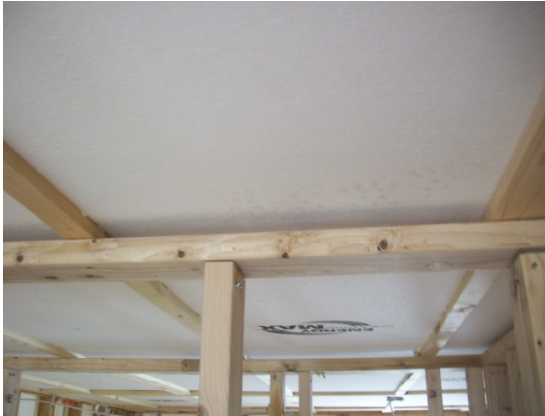
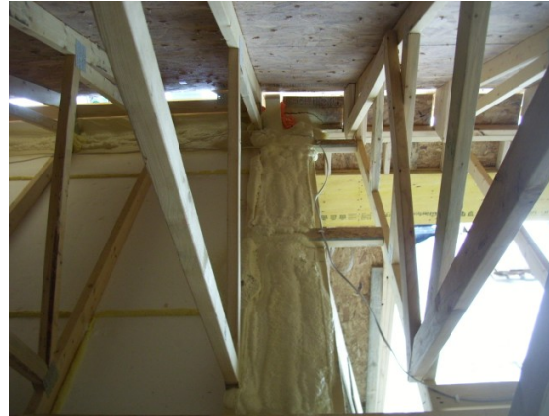
Figure 3.1

3 Top plate gaps

Gaps in framing at the top plate can lead to uneven interior surface temperatures and unconditioned air leakage in the structure. Foam all penetrations and apply sealant at the seam between double top plates when attaching poly to framing.

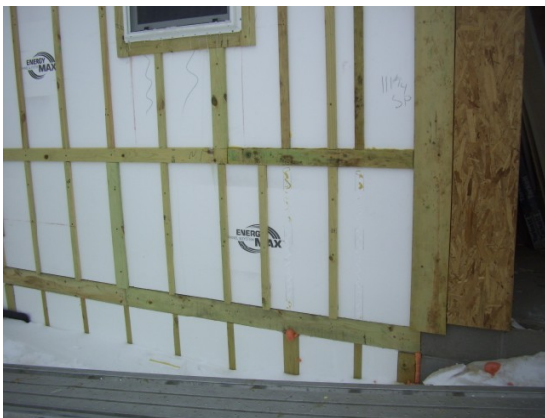
Figure 4.1

4 Insulation missing/voids/compressions

Insulation performance is reduced by voids and leads to building durability issues, uneven interior surface temperatures, occupant discomfort, and high utility costs. Install insulation in all cavities for full thermal coverage, without voids, gaps, and compressions and in full contact with the vapor barrier.

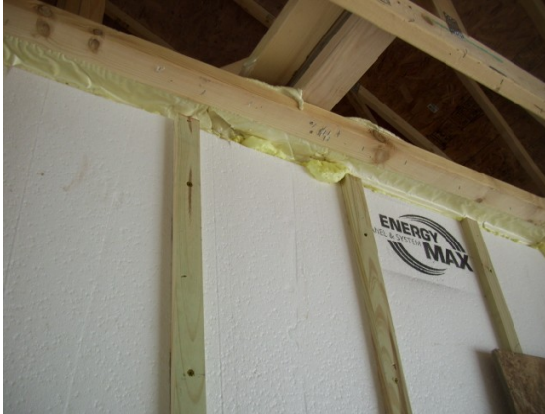
Figure 5.1

5 Attic framing/sheathing gaps

Gaps can lead to uneven interior surface temperatures and unconditioned air leakage into the structure. Seal all framing and sheathing gaps before insulation and vapor retarder are installed.

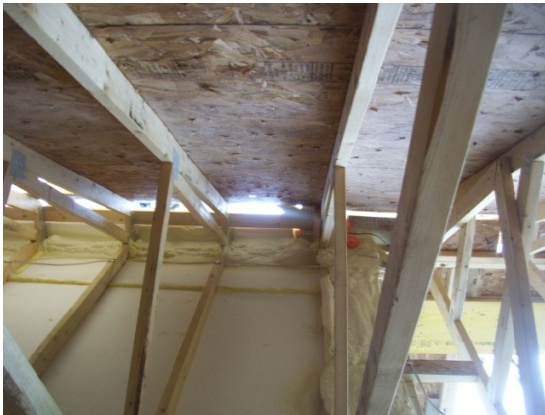
Figure 6.1

6 Wind wash baffle gaps

Gaps between the wind wash sheathing, attic chutes, and framing must be sealed to prevent air from blowing underneath attic insulation and cooling/heating the ceiling below. Air movement through attic insulation reduces the thermal performance of the insulation and can affect the comfort of occupants during both heating and cooling seasons. Foam / caulk gaps before insulation.
